## "Full" Reserve Study

## Chateau Chaumont Aspen, CO

**Report #: 32753-0**  
**For Period Beginning: July 1, 2017**  
**Expires: June 30, 2018**

**Date Prepared: October 6, 2017**

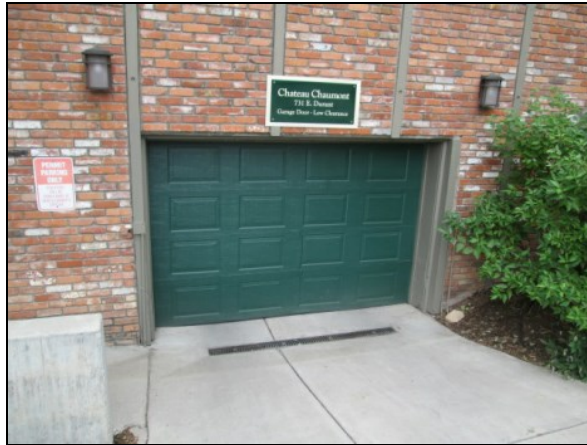
**Comp #: 2107 Garage Door - Replace**

History: Replaced in 2014

Useful Life:  
20 years

Remaining Life:  
17 years

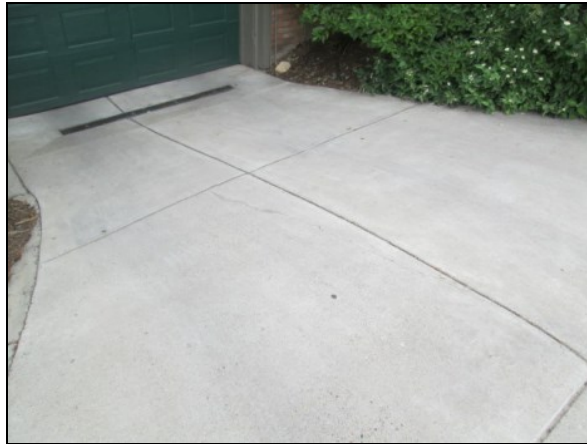
**Comp #: 2109 Snowmelt Ramp Concrete - Replace**

History: Replaced in 2007

Useful Life:  
30 years

Remaining Life:  
20 years
