## "Full" Reserve Study

## Chateau Chaumont Aspen, CO

**Report #: 32753-0**  
**For Period Beginning: July 1, 2017**  
**Expires: June 30, 2018**

**Date Prepared: October 6, 2017**

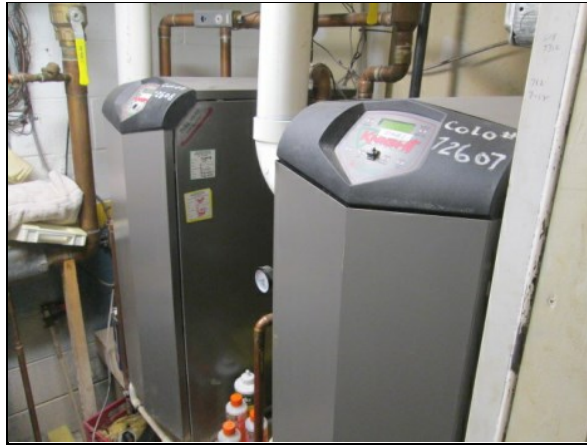
**Comp #: 2561 Boilers - Replace (399000 BTU)**

Evaluation: Model- KBN399. Serial E07H100. 399000 BTU. Minimal or no subjective/aesthetic value for this component. Useful life is based primarily on normal expectations for service/performance life in this location. Unless otherwise noted, remaining useful life expectancy is based primarily on original installation or last replacement/purchase date, our experience with similar systems/components, and assuming normal amount of usage and good preventive maintenance. [FUND] With routine inspection and maintenance, the boiler should have an approximate useful life as shown below before replacement with future technology and efficiencies will be warranted. Life expectancy can vary based on level of use and location on the property. When considering replacements, the Association should strongly consider replacing with high-efficiency models. Although initial cost may be higher than conventional alternatives, the payback period in energy savings is often a fraction of the overall life span of the boiler itself. Costs to replace are based on replacement with same approximate size and capacity.

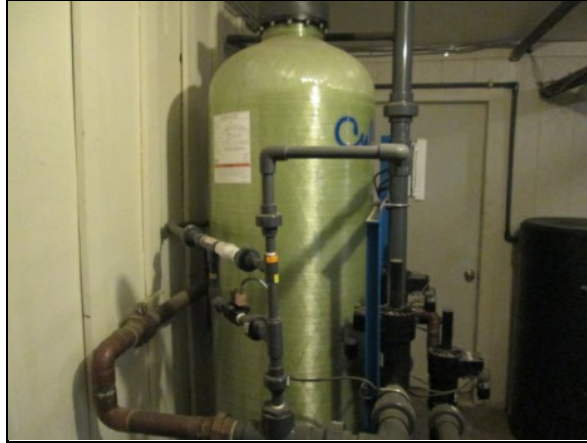
**Comp #: 2565 Water Softener Tank - Replace**

Evaluation: Culligan water softener tank. Minimal or no subjective/aesthetic value for this component. Useful life is based primarily on normal expectations for service/performance life in this location. Unless otherwise noted, remaining useful life expectancy is based primarily on original installation or last replacement/purchase date, our experience with similar systems/components, and assuming normal amount of usage and good preventive maintenance. Water softener storage tanks should be inspected for leaks and other problems routinely by servicing vendor or maintenance staff. Small repairs and cleaning should be considered an Operating expense and conducted as needed. Plan to replace at the approximate interval shown below, ideally coordinated with replacement of the boiler/hot water heater itself in order to achieve better pricing and minimize system downtime.

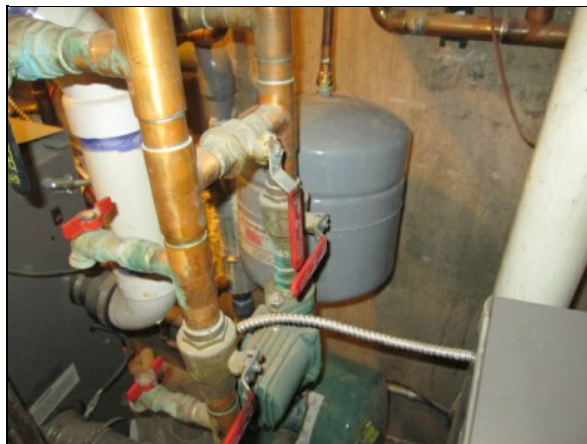
**Comp #: 2569 Expansion Tank - Replace**

Evaluation: Expansion tanks should be inspected for leaks and other problems routinely by servicing vendor or maintenance staff. Small repairs and cleaning should be considered an Operating expense and conducted as needed. Tanks are smaller and can be replaced as needed.

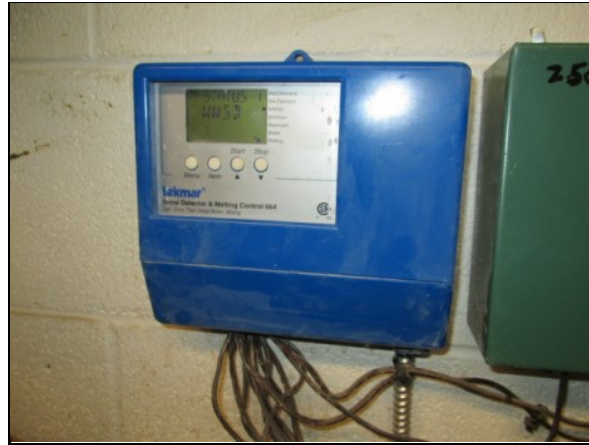
**Comp #: 2571 Boiler/Snowmelt Controller -Replace**

History: Replaced in 2007

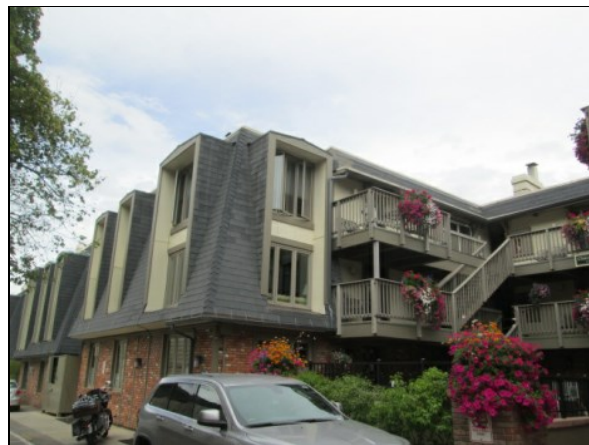
**Comp #: 2573 Plumbing System - Repair**

Evaluation: Client reportedly performed a large amount of work in 2016/2017 of ~ \$200k. Reportedly, the pipes had an epoxy liner installed to prevent potential leaking. Analysis of plumbing system(s) beyond visual inspection of visible piping is not within the scope of a Reserve Study. Some types of piping used historically are known to be life limited. Manufacturing defects may become apparent from time to time and certain site conditions can contribute to premature deterioration of system components. Typically, if installed per architectural specifications and local building codes, there is no predictable time frame for large scale repair/replacement expenses within the scope of our report. If leaks, poor flow, sediments, defective material and/or installation become evident, have qualified plumber and/or engineer evaluate in more detail and develop scope of any repair/replacement needed; funding for even one time projects can be incorporated within Reserve Study updates if warranted. Treat minor local repairs as ongoing maintenance expense. If patterns of significant repair costs emerge, funding may be incorporated into future Reserve Study updates to supplement the Operating budget. No basis for Reserve funding at this time.

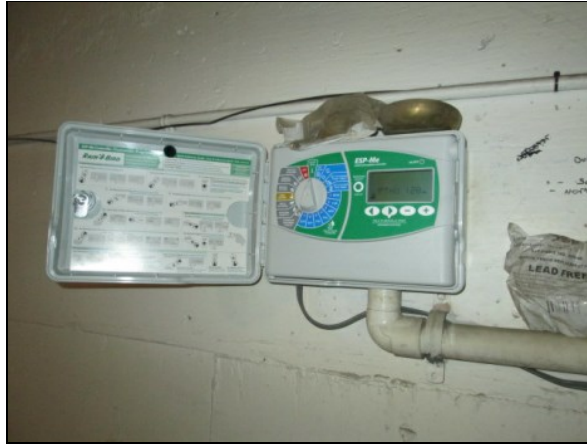
**Comp #: 2581 Irrigation Controller - Replace**

Evaluation: In general, costs related to this component are expected to be included in the Association's Operating budget. No recommendation for Reserve funding at this time. However, any repair and maintenance or other related expenditures should be tracked, and this component should be re-evaluated during future Reserve Study updates based on most recent information and data available at that time. If deemed appropriate for Reserve funding, component can be included in the funding plan at that time.

Funded?: No. Repair/replace using funds from the operating budget.

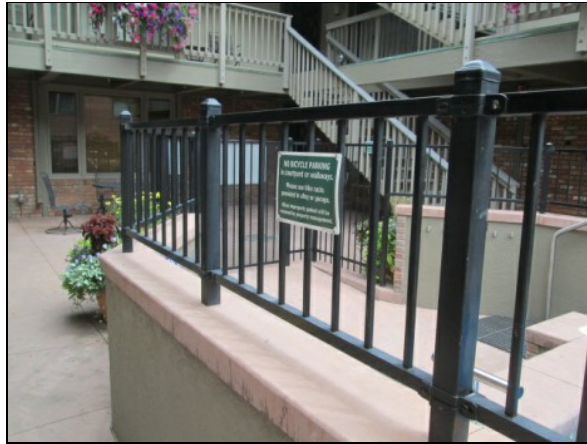
### Comp #: 2805 Fencing: Metal - Replace

Evaluation: appears to be powder coated. No painting is needed. Metal fencing determined to be in good physical/structural condition is stable and upright, with no signs or reports of damage or required repairs. All components and hardware appear to be in serviceable condition with no unusual or advanced signs of wear or age. Fencing is in good aesthetic condition. In our experience, metal fencing will typically eventually break down due to a combination of sun and weather exposure, which is sometimes exacerbated by other factors such as irrigation overspray, abuse and lack of preventive maintenance. For some types of fencing, complete replacement is advisable over recoating or refinishing due to relatively short lifespan of coatings and consideration of total life-cycle cost.

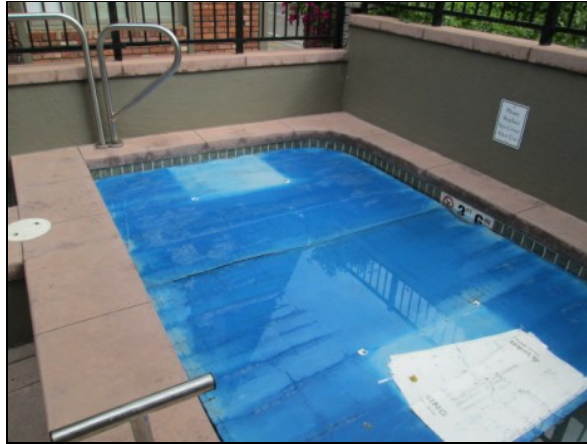
Evaluation: Spas sometimes need to be resurfaced more frequently than pools due to higher chance of chemical imbalances. Whenever possible, both should be done at the same time to achieve better pricing and minimize downtime. While drained for resurfacing, any other repairs to lighting, handrails, stairs, ladders, etc. should be conducted as needed. This type of project is best suited for slow/offseason to minimize downtime during periods when spa is used heavily.

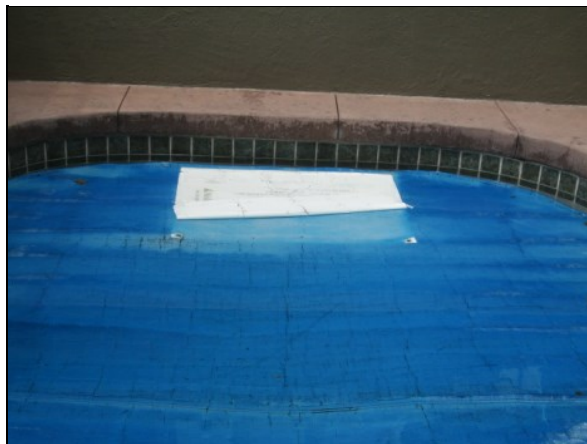
History: Replaced in 2010/2011

Evaluation: Pool/Spa was observed to be in good condition. Pavers did not exhibit any major cracking. Appearance was noted to be upholding appropriate aesthetic standards for the property. Small repairs to waterline tile should be done as needed as an Operating expense. Complete re-tiling is warranted at longer intervals to restore the look and feel of the interior finish. While drained for resurfacing, any other repairs to lighting, handrails, stairs, ladders, etc. should be conducted as needed. This type of project is best suited for slow/offseason to minimize downtime during periods when pool is used heavily. Should be expected at the approximate interval shown below to preserve this important amenity of the association.

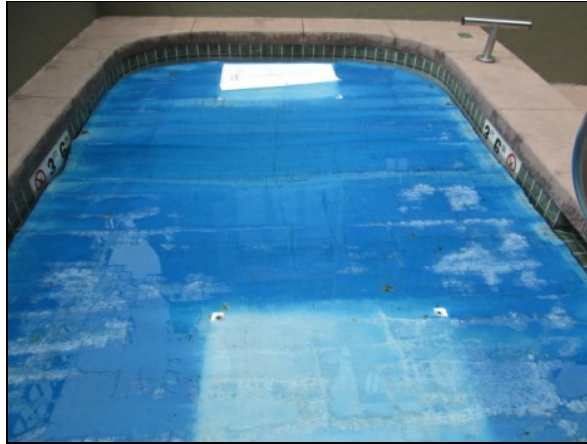
**Comp #: 2825 Spa Cover - Replace**

Evaluation: In general, costs related to this component are expected to be included in the Association's Operating budget. No recommendation for Reserve funding at this time. However, any repair and maintenance or other related expenditures should be tracked, and this component should be re-evaluated during future Reserve Study updates based on most recent information and data available at that time. If deemed appropriate for Reserve funding, component can be included in the funding plan at that time.

Funded?: No. Repair/replace as needed using funds from the operating budget.
